The D7 valve is manufactured from quality materials and has been engineered to ensure a long life in arduous marine environments. In the unlikely event that you experience problems with this product you may find the following notes helpful.

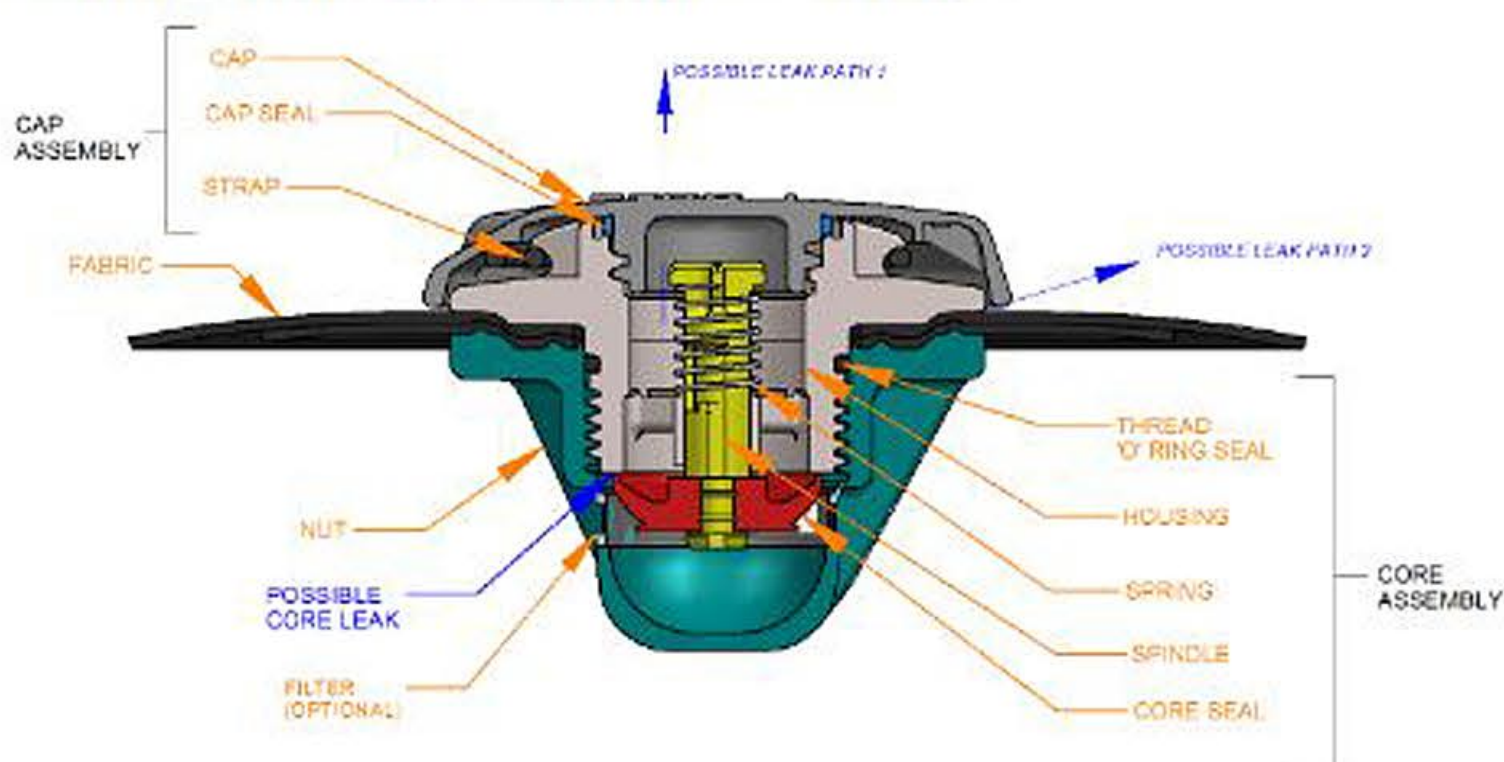
First identify where the leak is coming from- see diagram below.

### (a) Leakage Path 1 (from the Core Assembly).

### (b) Leakage Path 2 (from the edge of the Valve).

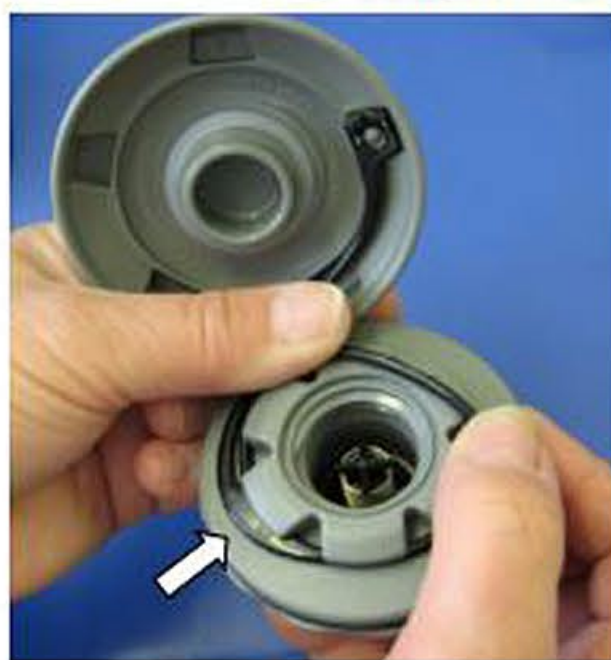
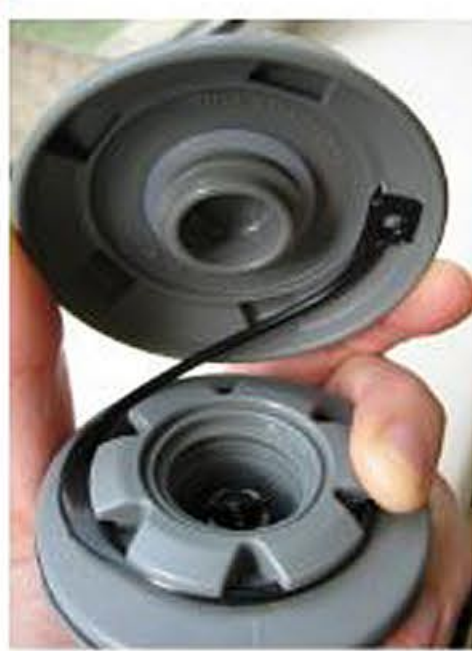
- (i) If the cap has been broken or the strap damaged, a new Cap/strap assembly can be obtained from your spares supplier. The loop securing the cap to the valve can be cut using a knife- being careful not to damage you or the raft fabric. The new loop can then be pushed over the retaining features (start with the thickest part of the strap) and will clip into place securing the cap firmly. Make sure the strap is the right way up before fitting, so there are no twists in the strap when you screw the cap on.
