The D7 valve is manufactured from quality materials and has been engineered to ensure a long life in arduous marine environments. In the unlikely event that you experience problems with this product you may find the following notes helpful.

If the problem is Leakage read section 1, if it is Breakage read section 2.

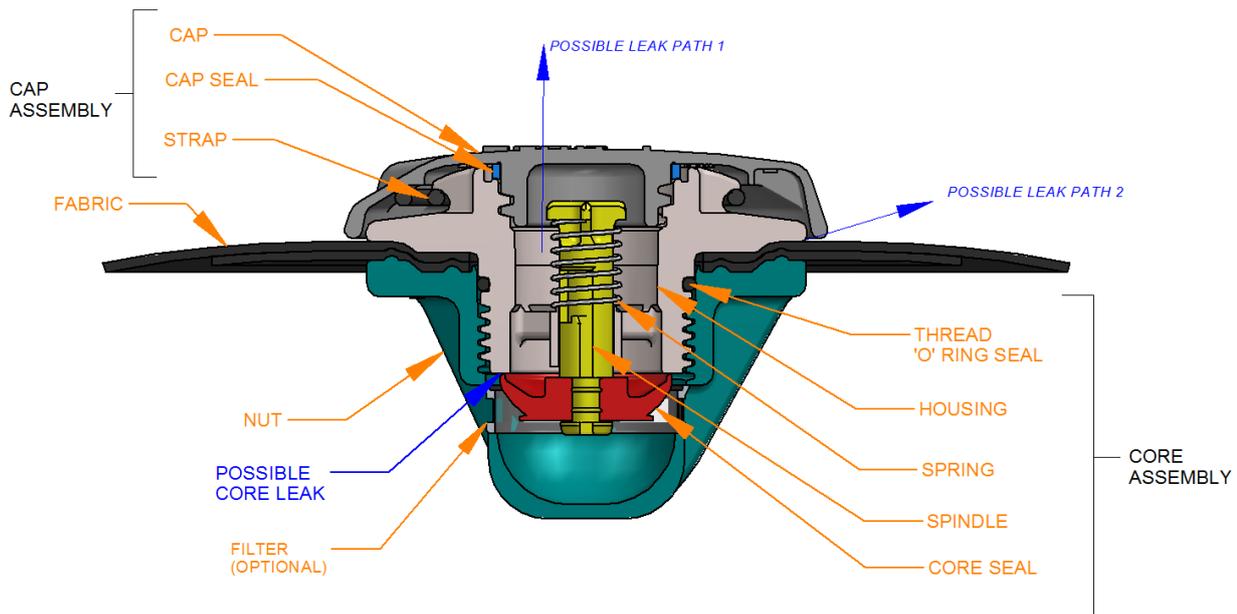
First identify where the leak is coming from- see diagram below.

### **(a) Leakage Path 1 (from the Core Assembly).**

This problem can be temporarily overcome by fitting the cap, as this is a secondary seal. To permanently fix the problem, carry out the following operations: -

- (i) With the buoyancy tube deflated and the valve in the closed position, remove the Cap, then fill the valve with some warm soapy water. Open the valve by pushing the Spindle down and turning anti-clockwise. Allow the water to drain through. Rinse through with plain water. Re-check the valve for air tightness.
- (ii) If the leakage persists, use service tool C16605 with the buoyancy deflated and unscrew the core of the valve by turning it anti-clockwise. Check the rubber seal on the valve core for dirt or damage. Check that the sealing face on the plastic core is clean and undamaged.
- (iii) Refit the valve and tighten as tightly as you can using hand pressure on the tool. Inflate the buoyancy tube and check for air tightness. We recommend that after around 24 hours the valve should be retightened to ensure it has fully seated. If the leakage persists contact your local repair shop.

(b) Leakage Path 2 (from the edge of the Valve).

- (i) Using tool C16605, ensure that the valve is as tight as possible with hand pressure only.
- (ii) If the leak persists, unscrew the valve core and remove. Remove the core and inspect the thread 'O' ring seal and the condition surface of fabric around the hole where the flange of the valve contacts the fabric.
- (iii) If the thread 'O' ring seal or core seal are damaged they must be replaced using the appropriate seal kit.

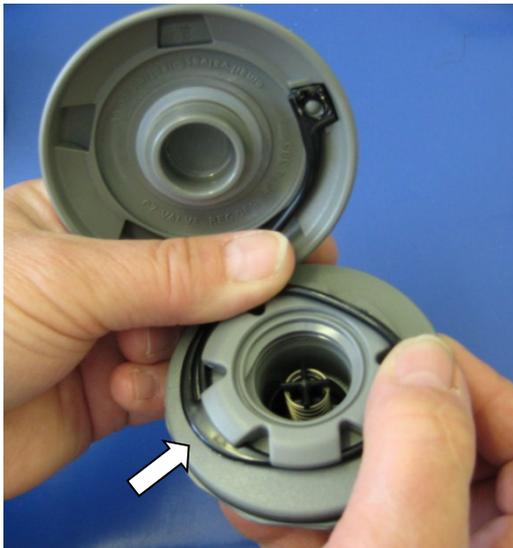
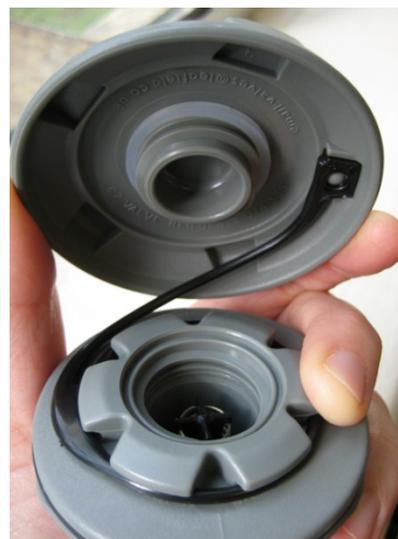
- (i) If the cap has been broken or the strap damaged, a new Cap/strap assembly can be obtained from your spares supplier. The loop securing the cap to the valve can be cut using a knife- being careful not to damage you or the raft fabric. The new loop can then be pushed over the retaining features (start with the thickest part of the strap) and will clip into place securing the cap firmly. Make sure the strap is the right way up before fitting, so there are no twists in the strap when you screw the cap on.
